# An effective landscape restoration approach to improving water quality on the Great Barrier Reef

Colleen James<sup>1</sup>, Geoffrey Titmarsh<sup>2</sup>, Carolyn Trewin<sup>3</sup>, Catalina Reyes<sup>3</sup>, Greg Oliver<sup>3</sup>, Milena Gongora<sup>3</sup> & Christian Roth<sup>4</sup>

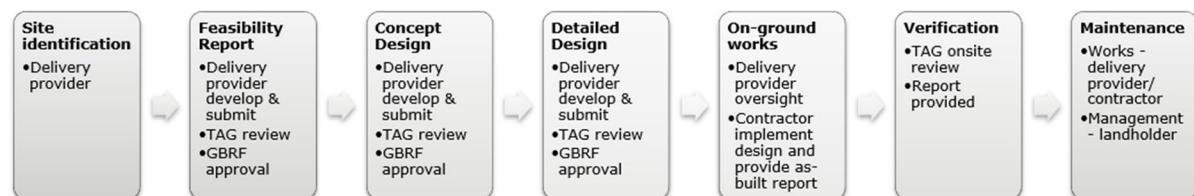
**Figure 1. RTP Landscape Restoration Program 7-step delivery approach**

Two general approaches were used to contribute to the ambitious sediment reduction targets – grazing practice change and landscape restoration. Hillslope erosion was addressed primarily through grazing practice improvement, small-scale earthworks, and low-cost interventions such as leaky weirs to stabilise soil and slow sediment transportation. In contrast, the Landscape Restoration Program (LRP) was designed to deliver large-scale reconstruction of extensive gully networks and eroded streambanks. To maximise the efficiency of the investment, projects were selected based on cost-effectiveness (C/E). A 7-step delivery approach (Figure 1) was designed to meet technical demands, mitigate risks, and ensure the most effective use of RTP funding. Throughout the delivery program, this approach was refined to be more robust and effective, the steps are expanded below.

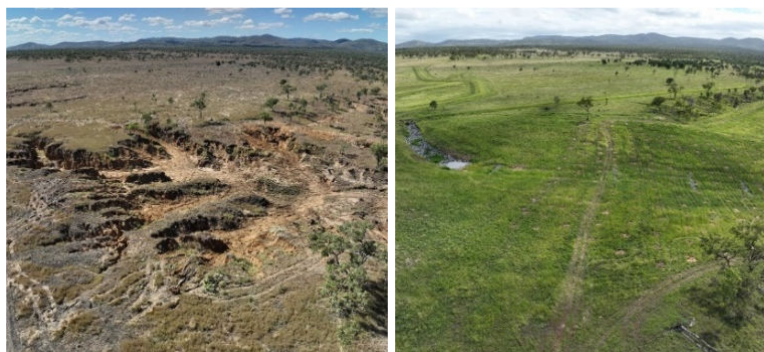
**Figure 2. Example of LRP alluvial gully site before (May 2023) and after (March 2024) remediation. Actions included reshaping, diversion bank and associated rock chutes, porous rock check dams, soil amelioration, revegetation, fencing, and grazing management.**

Gully remediation works were delivered in the Fitzroy, Burdekin and Herbert regions (detailed in Table 1 below). Alluvial gully remediation site interventions (example in Figure 2) included a mix of land reshaping, diversion banks and associated rock chutes, porous rock check dams, batter drains, soil amelioration, revegetation (native endemic to the area), fencing, and grazing management.

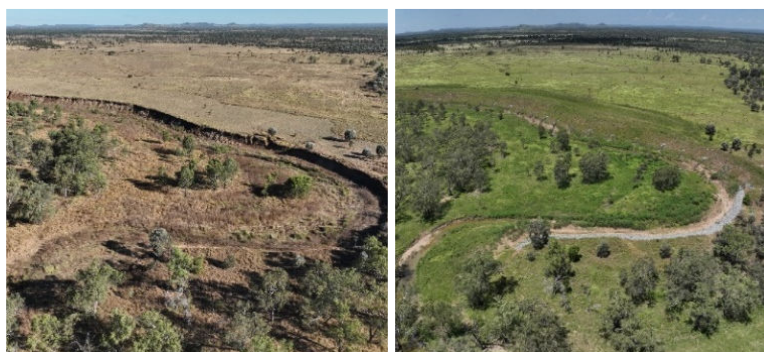
**Figure 3. Example of LRP streambank site before (Nov 2024) and after (March 2025) rehabilitation. Actions included vertical bank battering and construction of rock chute, batter drains, bunds, rock beaching, and pile fields; soil amelioration, revegetation, fencing, and grazing management.**

Streambank restoration works were delivered in the Mary, Fitzroy, Burdekin, and Herbert regions (detailed in Table 2 below). Interventions included reshaping, pile field installation, rock beaching, fencing, revegetation, irrigation systems, and grazing management (example in Figure 3).

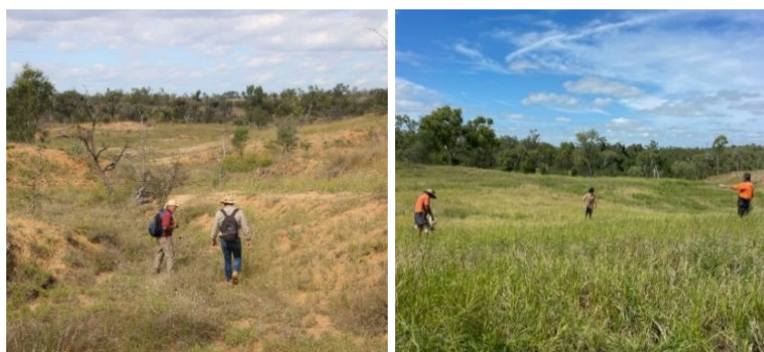
**Figure 4. Quality of vegetation establishment. Image left; poor recruitment of vegetation (cattle onsite). Image right; strong groundcover establishment (comprehensive soil testing and cattle exclusion).**

Onsite reviews of on-ground works at both gully and streambank sites found that in most cases significant dieback was experienced where revegetation activities did not include monitoring and watering (particularly for tube stock). Sites with implemented monitoring, management and irrigation had strong vegetation recruitment (example in Figure 4). This indicates that during the vegetation establishment phase, investment in monitoring and irrigation is essential.

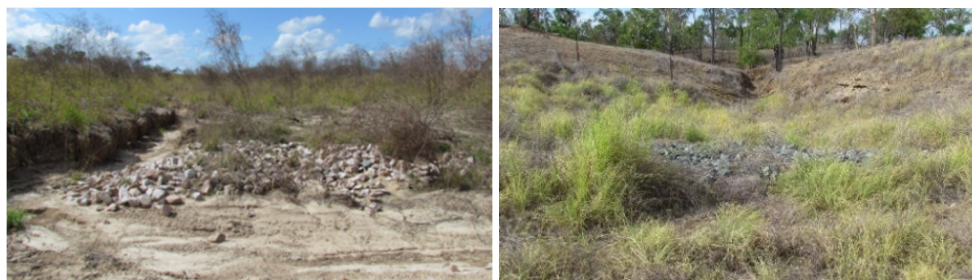
**Figure 5. Poor and good porous rock check dam implementation. Image left; outflanking of PCD abutments. Image right; constructed as per design with no outflanking.**

Specialist skills are required for the construction of works as per detailed designs. Specifically, this applies to the installation of rock chutes that provide a stable flow transition to a lower bed level and the temporary porous rock check dams (PCD)s used in low velocity channels to trap sediment and encourage vegetation growth. When designed, constructed, and maintained appropriately, these interventions are effective (Abbasi, et al., 2019). However, onsite verification of a semi-randomised selection of on-ground works found that all rock chutes (13/13) and most PCDs (30/39) reviewed had some form of departure from design. A common issue was the mismatch between specified and available rock sizes during construction. Any departure from design during construction can lead to potential failure in the short to medium term (example in Figure 5). Specialist oversight and supervision of construction should be provided to achieve the design intent. Where project investment is large (>\$250,000), construction works should be audited by a suitably qualified person at control points during construction for compliance to design specification.
